The project: "Renovation of Old Village Centre in Ponikva and Outdoor Area between the Church and the Parking Lot, including the Restoration of Public Utilities"

# V ZAVETJU CERKVE SV. MARTINA Arheološka odkritja 2012-2018

IN THE SHELTER OF ST. MARTIN'S CHURCH  
Archaeological findings 2012-2018

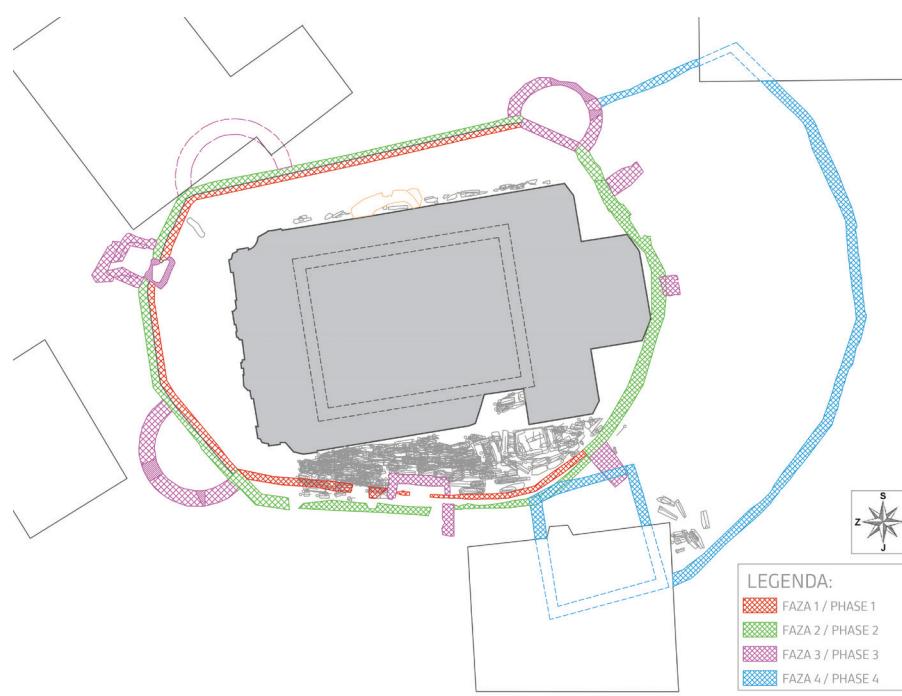
Jugovzhodni stolp in del obzidja / South-eastern tower and part of fortification  
Pokopališki zid z utrditvijo / Cemetery wall and its fortification

Archaeological research has confirmed the existence of the narrow cemetery wall (phase 1) and its fortification (phase 2), as discoveries included the remains of the foundations or walls of the fortification built in the late 15th century with the addition of a scarp and defence towers (phase 3) to defend against the Ottoman invasions. The discoveries also included all four defence towers – a part of the semi-circular north-western tower, semi-circular south-western tower with an entrance that was later walled-off, a side arrow slit and a drain channel, semi-circular north-eastern tower with an arrow slit and walled-off entrance, and the rectangular south-eastern tower. So-called offset entrances were documented on the southern and the north-western part of the fortified walls. Subsequently, the walls on the eastern end were buttressed and expanded with external walls terminating in the square-shaped south-eastern tower (phase 4).

Arheološke raziskave so potrdile obstoj ožjega pokopališkega zidu (faza 1) ter njegove utrditve (faza 2). Odkrite so bile namreč ostaline temeljev oziroma zidov konec 15. stoletja postavljenega protiturškega tabora, ki je nastal z utrditvijo pokopališkega zidu z dodatno fronto in obrambnimi stolpi (faza 3). Odkriti so bili tudi vsi štirje obramni stolpi - del polkrožnega severozahodnega stolpa, polkrožni jugozahodni stolp s poznej zazidanim vhodom, stransko lino in odvodnim kanalom, polkrožni severovzhodni stolp s strelno lino in zazidanim vhodom ter pravokotni jugovzhodni stolp. Na južnem in severozahodnem delu tabornega obzidja sta bila dokumentirana t. i. zamaknjena vhoda. Kasneje je bilo obzidje na vzhodnem delu podprtzo oporniki in razširjeno z zunanjim obzidjem, ki se je zaključil s kvadratnim jugovzhodnim stolpom (faza 4).

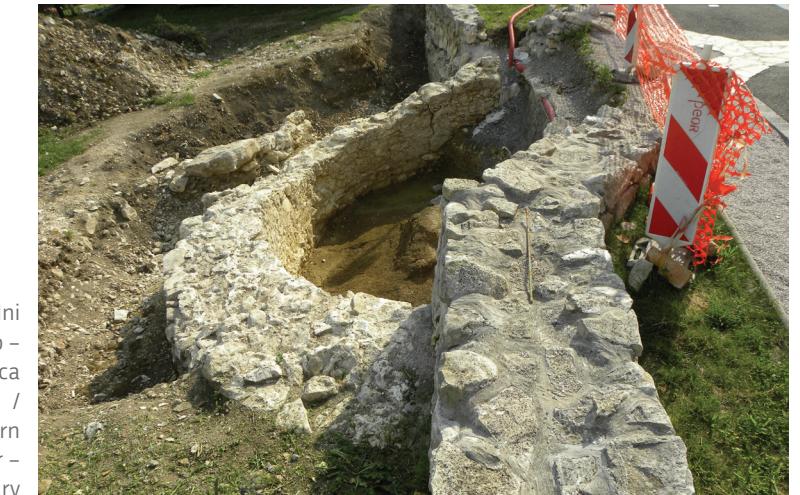
Severovzhodni stolp - kostnica / North-eastern tower - ossuary

Due to the limited space available for the cemetery, the north-eastern tower of the former fortification against the Ottoman invasion was later converted into an ossuary. Remains of the deceased from previous generations were transferred there to make space for the new departed. This practice must have been observed for a long time, as between 2,600 and 2,900 deceased were moved to the ossuary.

Zaradi prostorske omejenosti pokopališča je bila v severovzhodnem stolpu nekdanjega protiturškega tabora pozneje urejena kostnica. Vanjo so premeščali posmrtnе ostanke pokojnikov prejšnjih generacij, s čimer je bil sproščen prostor za nove umrle. Praksa je morala biti v veljavi dolgo časa, saj je bilo v kostnico prenesenih med 2600 in 2900 pokojnikov. Pokopališče ob gotski cerkvi je bilo v 18. stoletju premeščeno na Gmajno, od leta 1830 naprej pa prostor zadnjega počitka predstavlja današnje pokopališče. Pokojniki, odkriti med arheološkimi raziskavami, so pietetno pokopani v skupni grobni na današnjem pokopališču.
